The surveillance programme for *Aphanomyces astaci* in Norway 2018

Norwegian Food Safety Authority

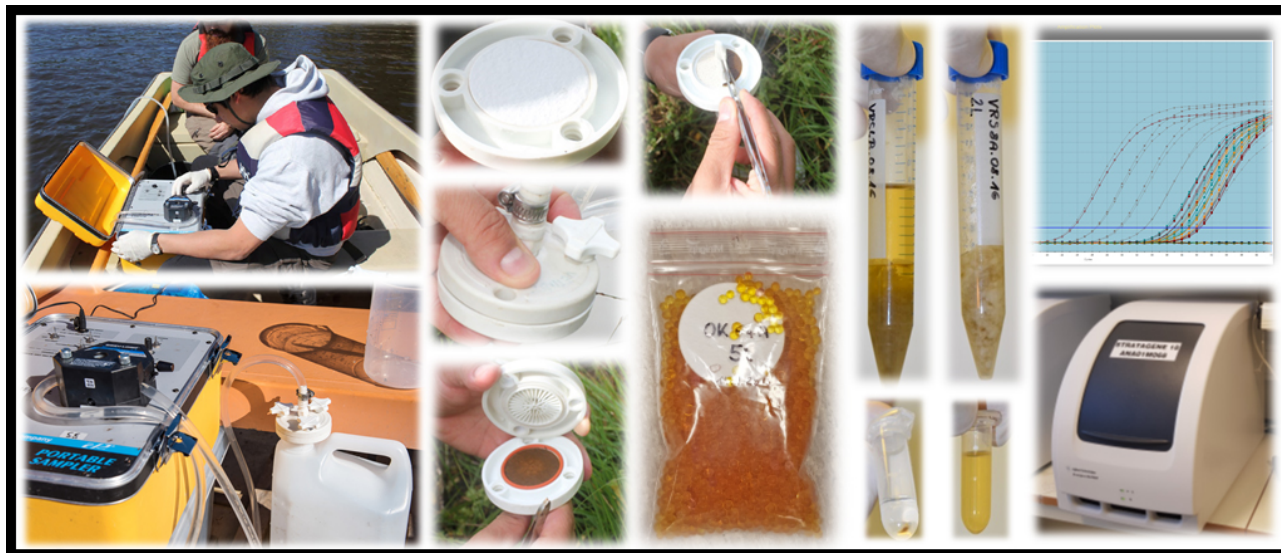
Figure 3. Water samples of ~5 L each were filtered on-site through glass fibre filters using a portable peristaltic pump (Masterflex E/S portable sampler). Each filter was carefully transferred to ziplock bag containing silica-gel beads for preservation until transportation to the laboratory. DNA was isolated with a large volume extraction procedure and presence/absence of eDNA from all target organisms was analysed using qPCR. Figure modified from Vrålstad et al (6).

The water samples were screened by qPCR for three DNA targets: the species specific qPCR assay for *A. astaci* (10, 12) and two crayfish species specific qPCR assays for noble crayfish and signal crayfish developed by Agersnap et al. (13). Figure 3 presents an overview of the eDNA monitoring procedure.
